# Manhole Inspection Summary

Manhole # S21A\_\_011MH

Insp Date: **9/14/07 7:47 AM**

**Location** Address: **708 ALLEY-FULTON-MOUNT**

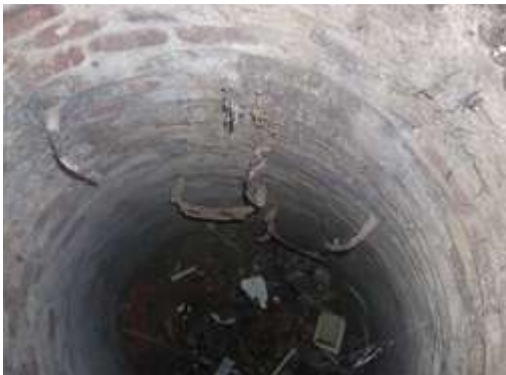
Defect 3

Count: **2** Missing: **3** ☒ **Corroded**

CORRODED AND MISSING STEPS

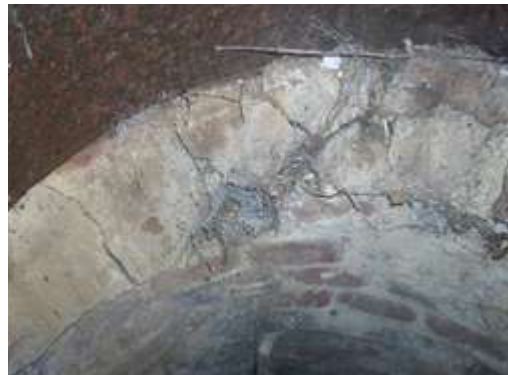
Defect 2

☒ Exists Material: **Brick and Concrete** ☐ Parged Height: **6** (in.)

Condition: ☐ Sound ☒ **Cracked** ☐ Root Intrusion ☐ Loose Brick ☒ **Deteriorated**

CRACKED AND DETERIORATED CHIMNEY

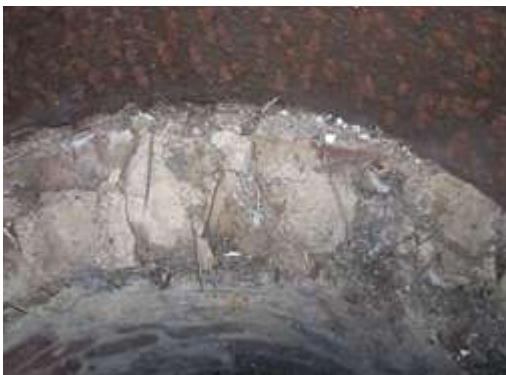
Defect 1

Offset: **3** (in.)

FRAME OFFSET

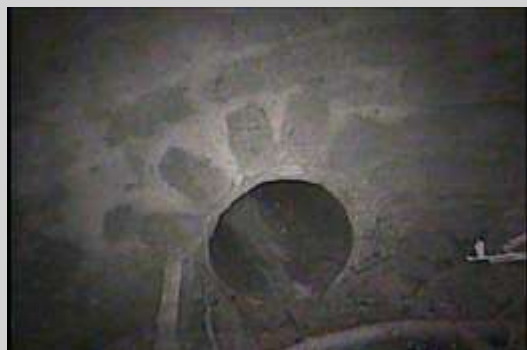
12 O'Clock Outflow

8 in. Circular Gravity Sewer  
Pipe Out @ 12 O'Clock

Infiltration: **None** Pipe Seal Cond: **Sound**
